**CAP 704**

**Aircraft Call Sign Confusion Evaluation Safety Study**

**April 2000**

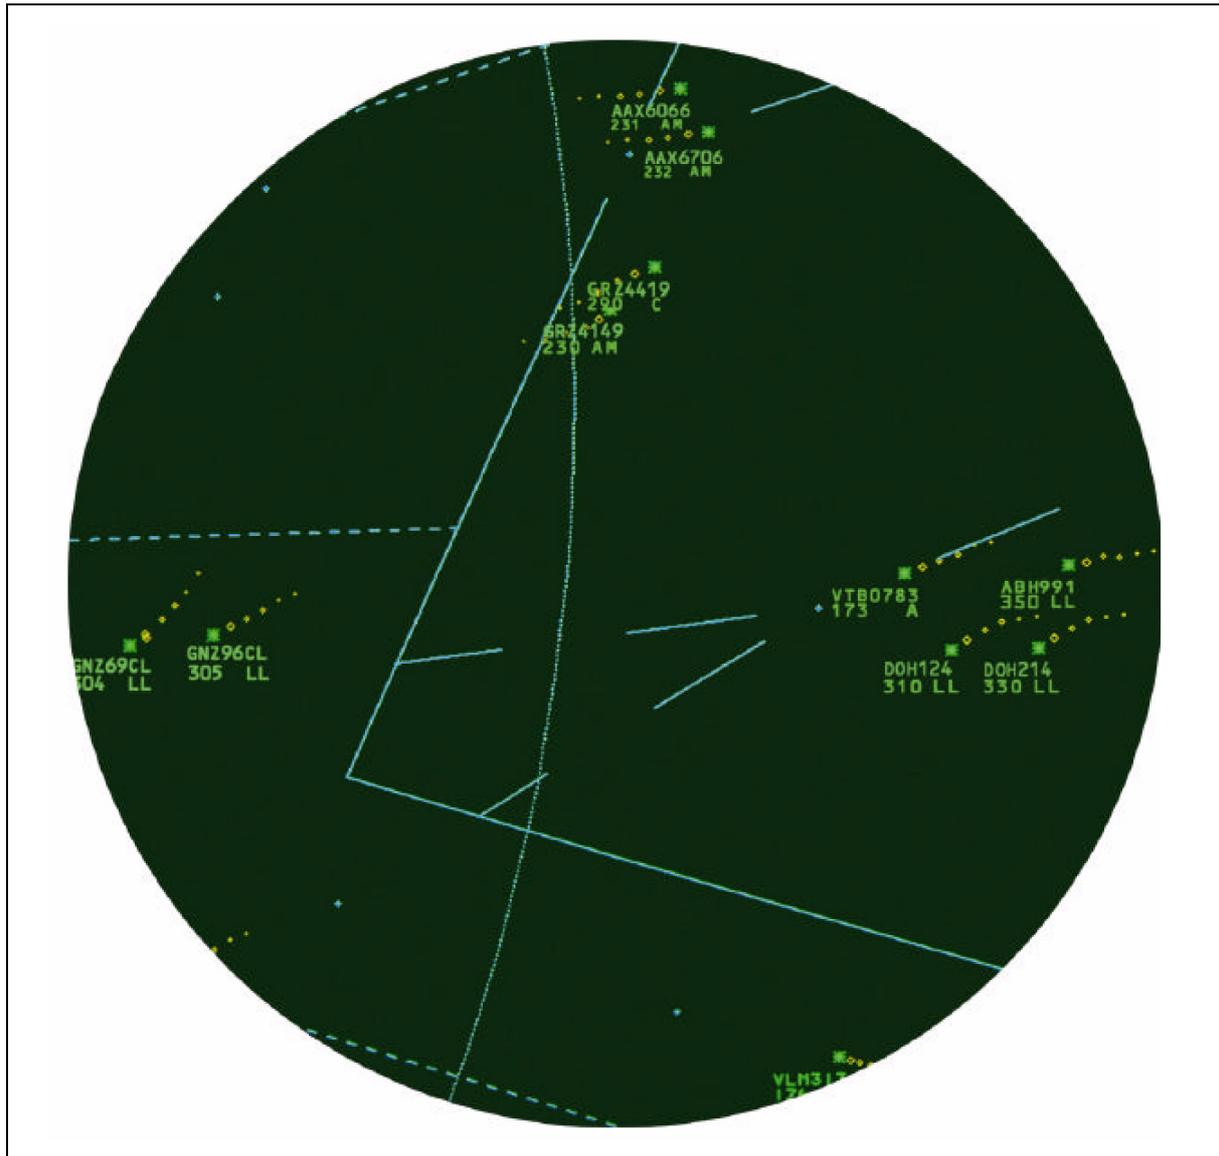
The radar picture below, is a view of a typical LATCC Sector display showing the visual call sign confusion problems faced by radar controllers. It gives a graphic example of the type of actual confusion or potential confusion that can arise. Whilst aircraft using similar designator letter groups in the call sign prefix, it is the use of the same, similar or, combinations of the same numbers/letters in the call sign suffix, that is most likely to mislead a radar controller.

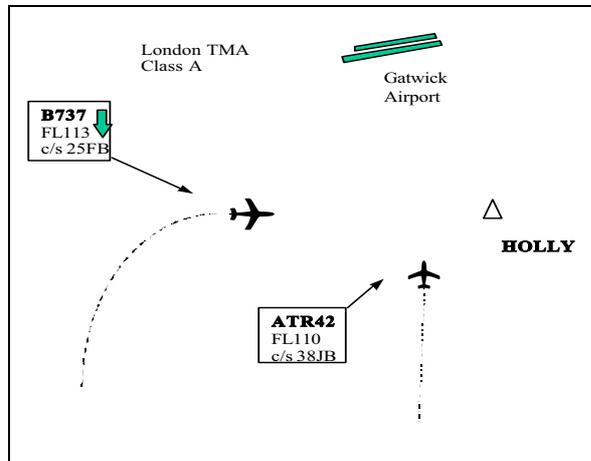
### Occ No. 97/00977

The principal cause of this AIRPROX was the trainee controller who did not use a fail safe separation method whilst positioning the subject aircraft towards HOLLY for their approach to Gatwick. The mentor controller did not detect the trainee's error in instructing the B737(25FB) to route to HOLLY which put it into conflict with the ATR42 (38JB) and was therefore not able to challenge his trainee's actions or to take appropriate measures to control the situation before a loss of separation occurred. RTF callsign confusion played a major contributory role in this occurrence which was initiated when the

pilot of ATR42 (24GB) replied to the turn and descent clearance addressed to the pilot of ATR42 (38JB) and this readback was not detected by either controller. Indeed the callsign confusion caused all the pilots and the controllers to make errors throughout the incident and immediately afterwards.

In short, therefore, the JAAP agreed that the incident had been caused when the B737 was directed towards HOLLY in the anticipation that the ATR42 (38JB) was also going to turn and descend. This was not a wise course of action and, additionally, neither the mentor nor trainee detected that the readback came from the wrong aircraft or noticed that the ATR42 (38JB) had neither turned or descended. The latter point confirms that callsign confusion initiated the AIRPROX and must therefore be considered as a major contributory factor.
