ANNEX K TO PIR REPORT DATED APRIL 2017

Detailed data obtained by GAL from airlines and CAA assessment of data.

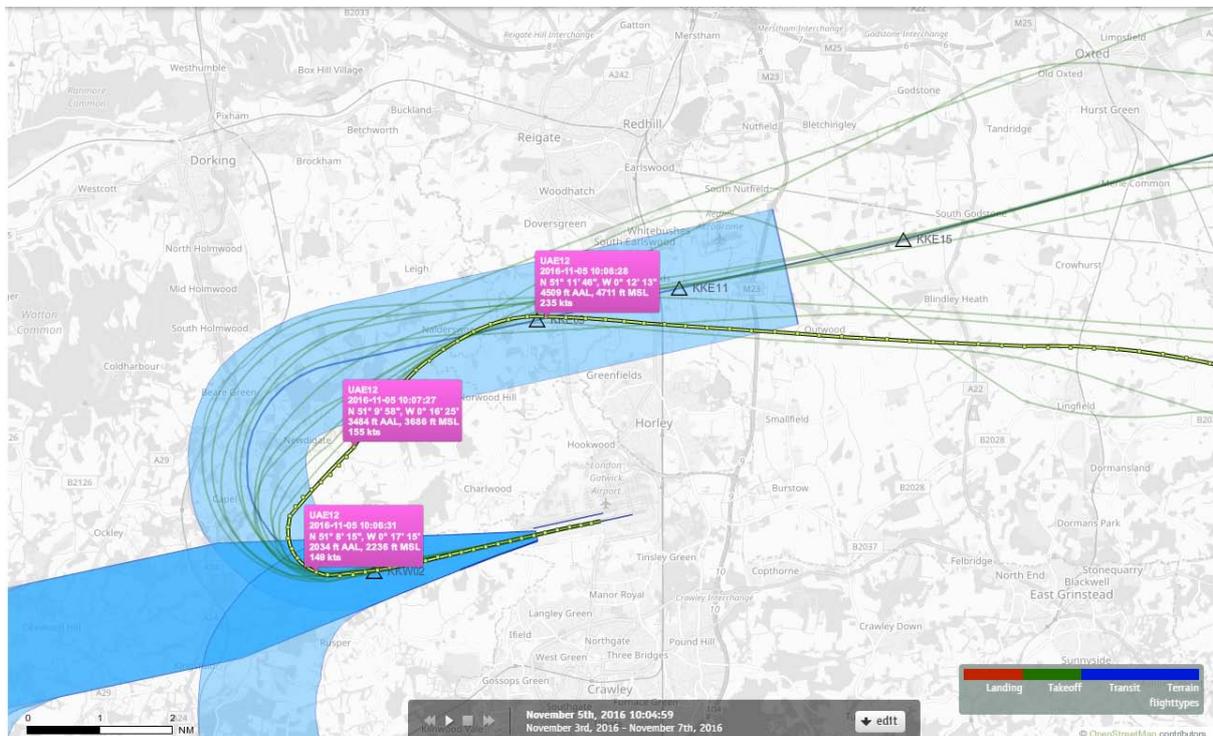
Figure 1

This airline permits its A380 flight crews to apply either of two different Noise Abatement Departure Procedure profiles. One of these departure procedures results in a low speed on

departure and the aircraft turning very tightly to head to intercept the downwind track and consequently cutting the inside corner of the NPR.

GAL has engaged with this airline to determine why different profiles are being flown and this work is ongoing. Flight tracks provided by GAL have shown that when the A380 is flown on the departure turn to intercept the easterly track to KKE09 at groundspeeds above 170/180kts then the resulting tracks were shown to be inside the NPR swathes. Further work is required by GAL to ensure that the SOPs employed by this airline will consistently ensure that the track adherence is towards the centre of the NPR swathe.

This issue is highlighted in Figure 1.
